# **STRUCTURAL EVALUATION REPORT PHASE II**

**SUFFOLK CITY HALL  
SUFFOLK, VIRGINIA**

**WTS PROJECT NO. 0706-F**

**FINAL ROUGH DRAFT  
30 APRIL 2010**

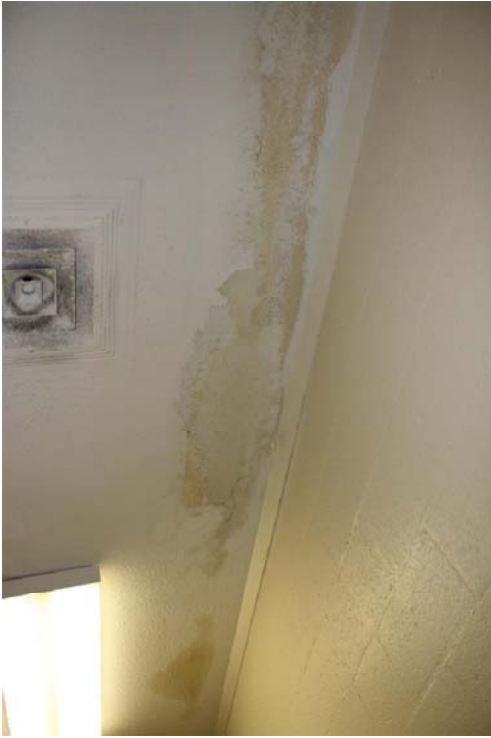
2-2b. Moisture damage in ceiling

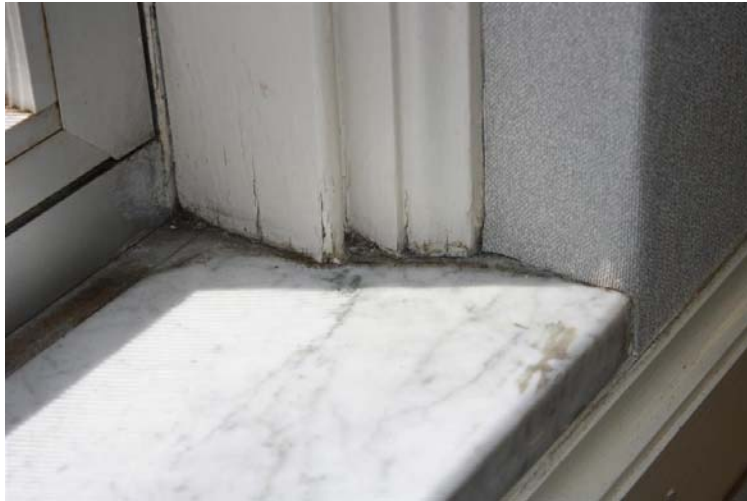
2-3a. Moisture damage at window jamb

Both in the City Hall Building and the Old Police Building, there are many areas where moisture damage is apparent around window openings. Wood casing is exhibiting deterioration and paint is peeling in some locations. In the City Hall Building, wall coverings have been replaced in recent renovations, concealing other potential interior moisture damage.
